## TEST REPORT

Report No. : HL70321A/2020

Product Description: Office Chair

Style/Item No.: Therapod XHR(D109)

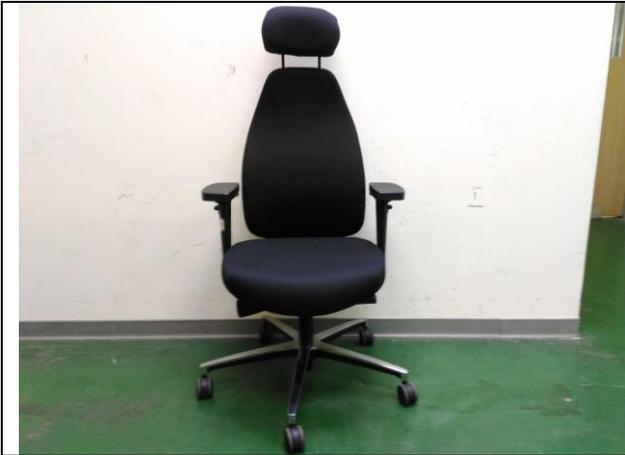
Photo A: Appearance of the sample - front

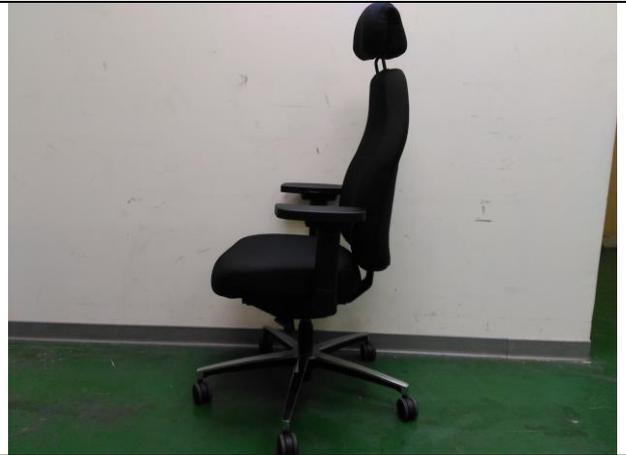
Photo B: Appearance of the sample - side

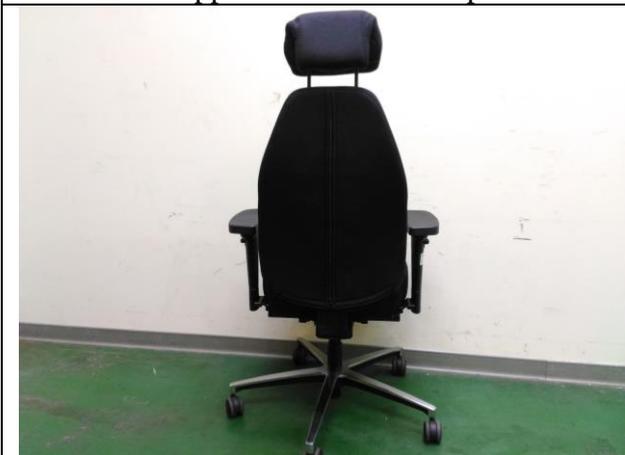
Photo C: Appearance of the sample - back

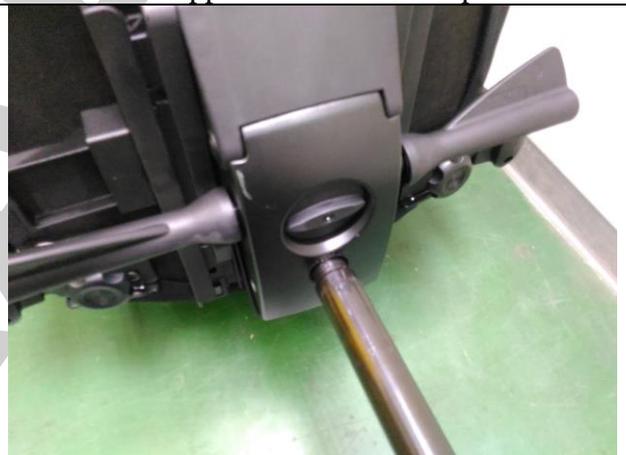
Photo D: Type(s) of the chair

Type of chair: TYPE I, Tilting chair (with tilt locks, locking the chair changes to type III, fixed seat angle, fixed backrest)
